## VEHICLE INSPECTION REPORT

**BV67GSU**

### Volkswagen Crafter CR35 2.0 TDI BMT 109PS

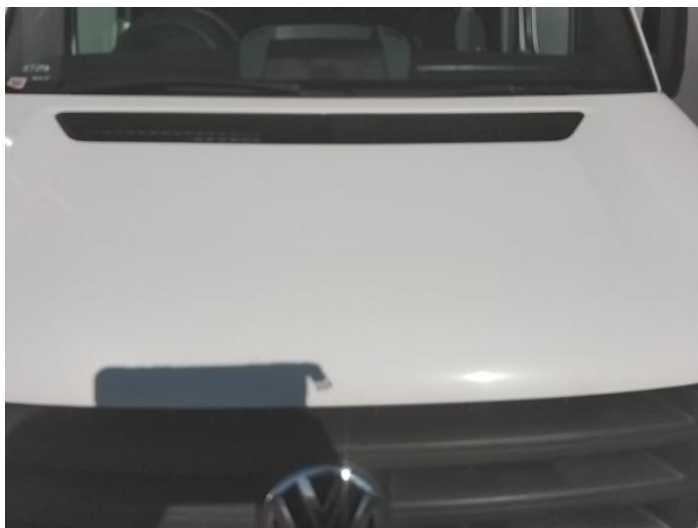
1: Bonnet  
Chipped  
Multiple Chips

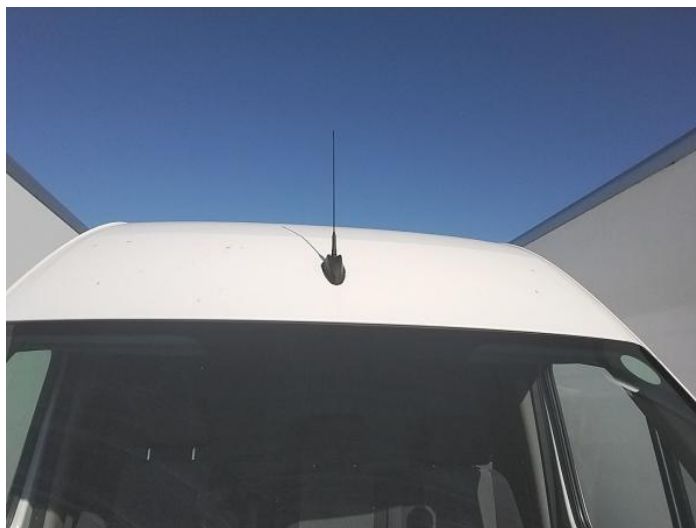
2: Roof  
Chipped  
Multiple Chips

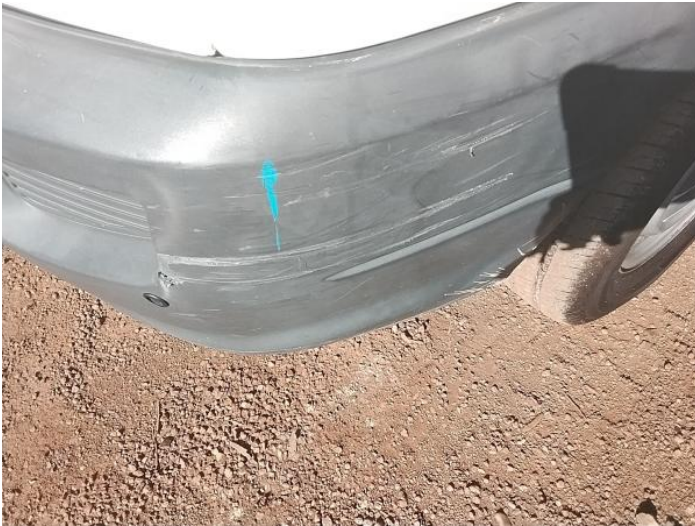
3: Bumper Front  
Hole  
UpTo 25mm

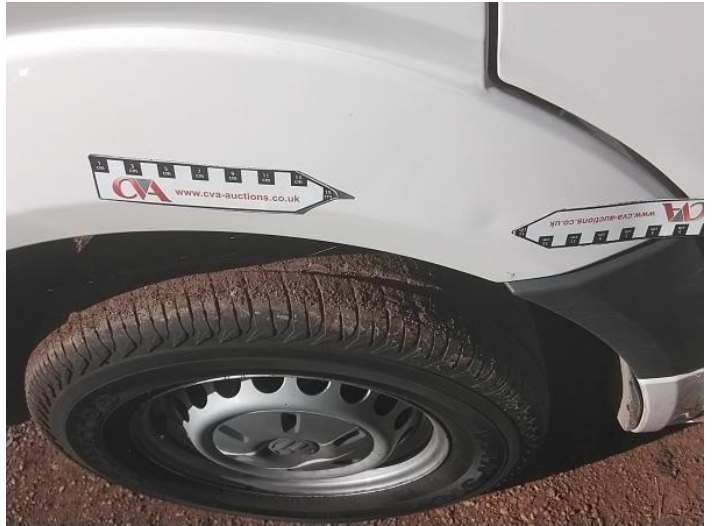
4: Wing nsf  
Dented  
Over 30mm

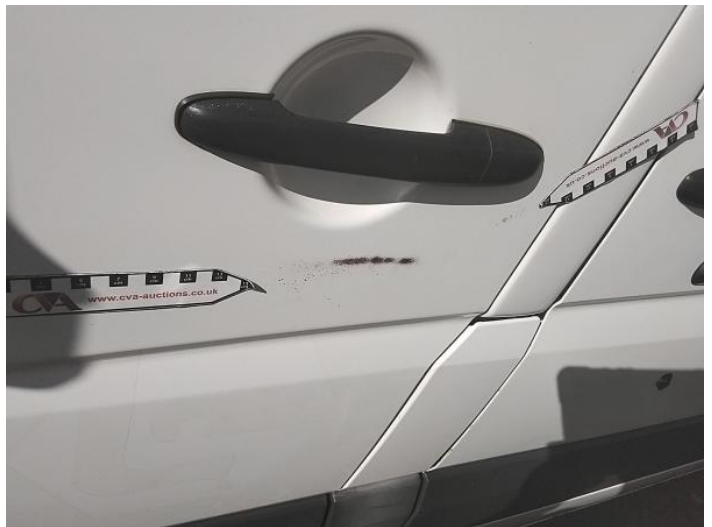
6: Door nsf  
Scratched  
Over 25mm Thru Paint

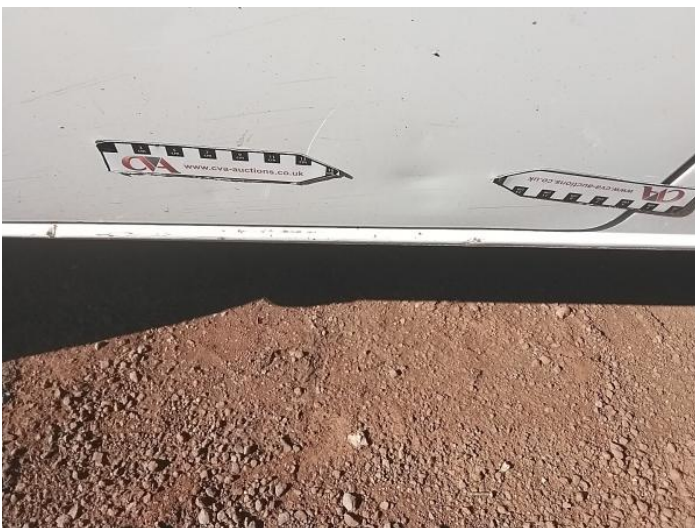
7: Door nsf  
Dented  
Over 30mm

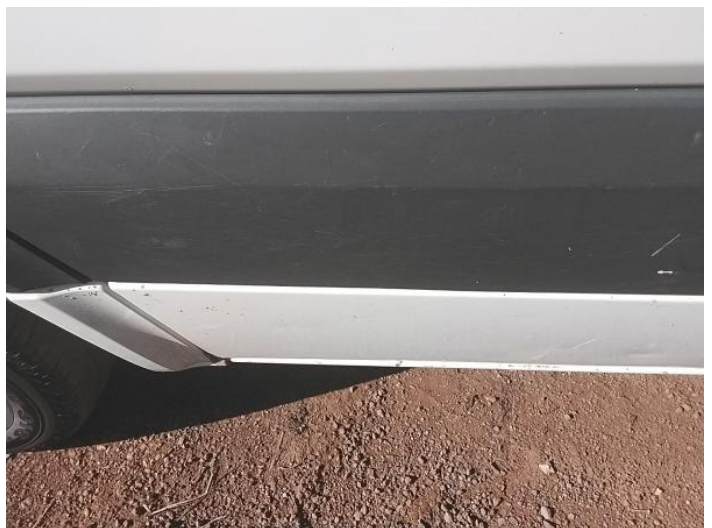
8: Door Moulding nsf  
Scuffed (Unpainted)  
Over 100mm

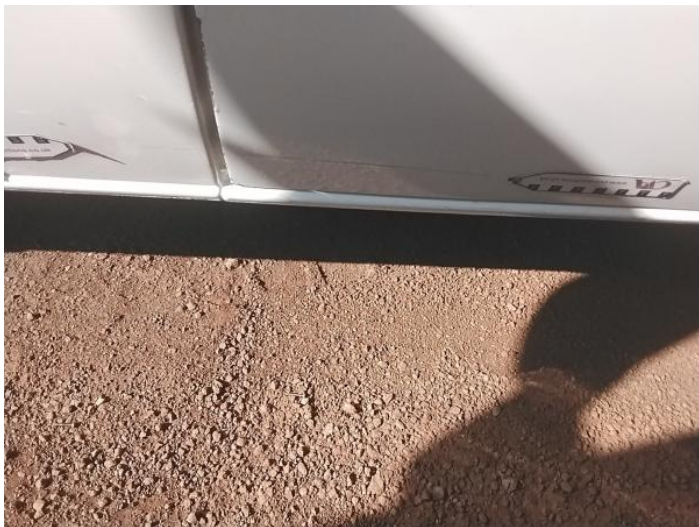
9: Qtr Panel nsr  
Scratched  
Over 25mm Not Thru Paint

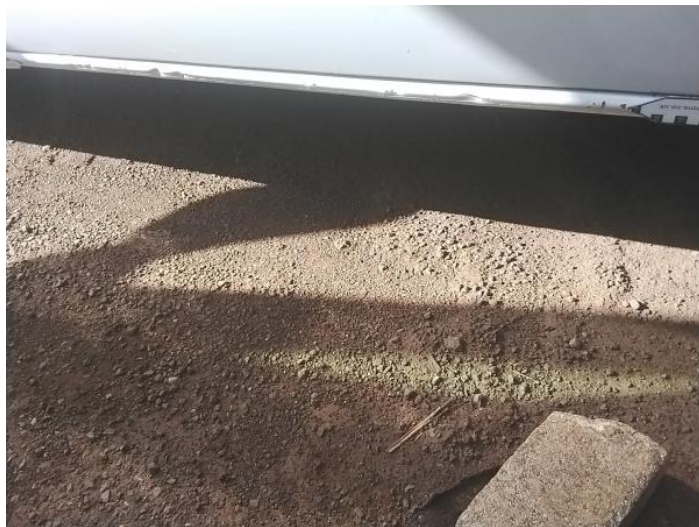
10: Sill ns  
Dented  
With Paint Damage

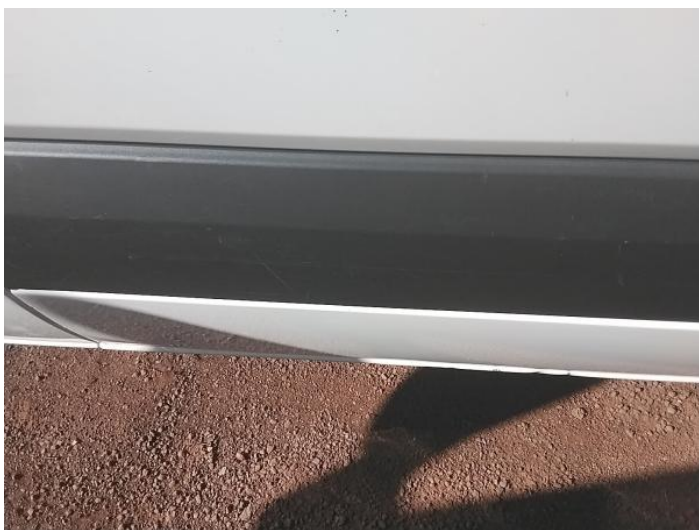
11: Qtr Panel Moulding ns  
Scuffed (Unpainted)  
Over 100mm

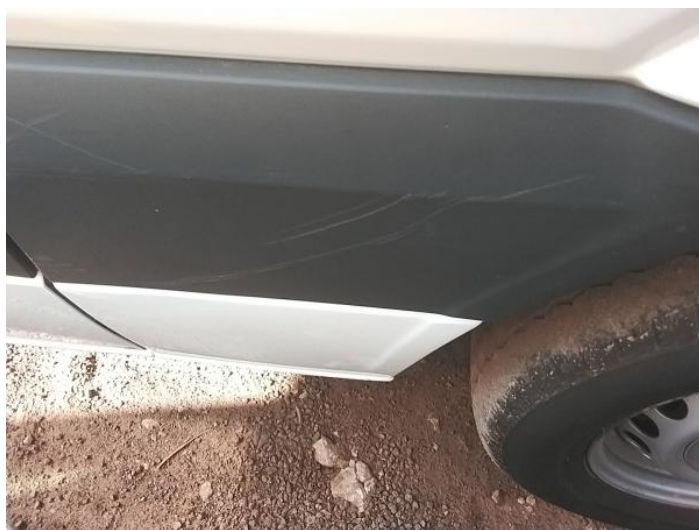
12: Qtr Panel Moulding ns  
Scuffed (Unpainted)  
Over 100mm

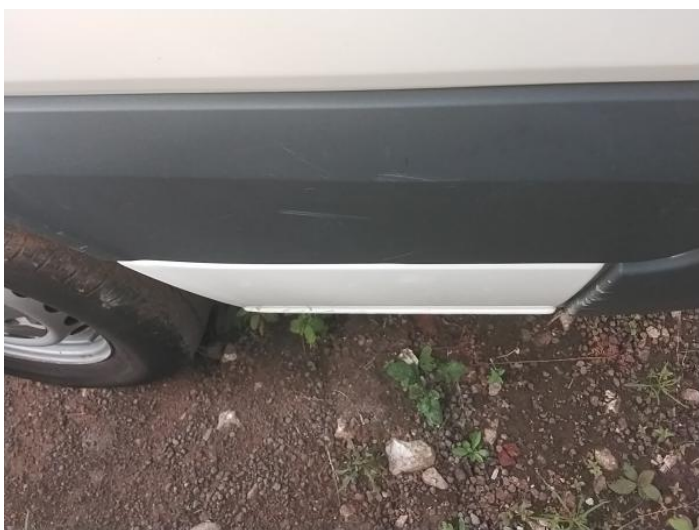
13: Qtr Panel Moulding ns  
Scuffed (Unpainted)  
Over 100mm

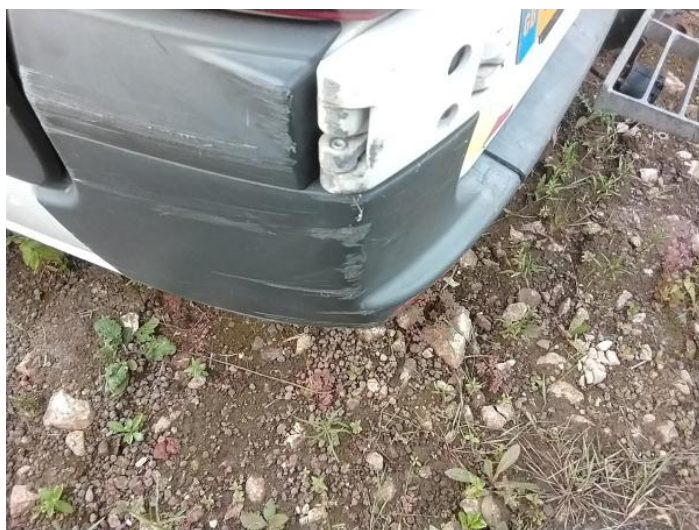
14: Bumper Rear Moulding  
Scuffed (Unpainted)  
Over 100mm

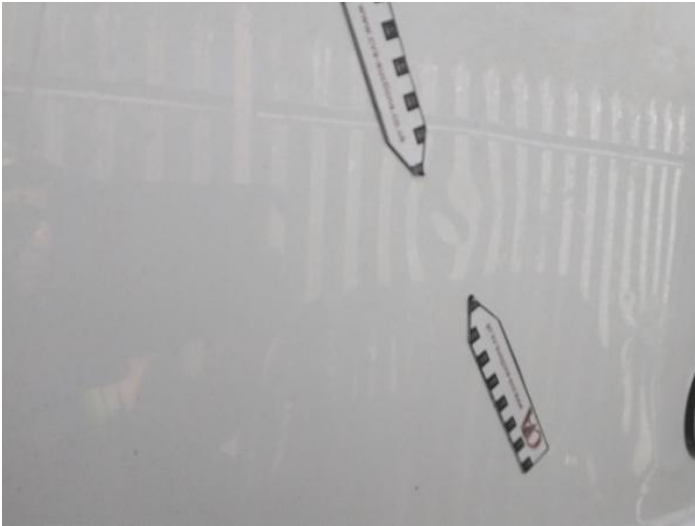
15: Door nsr  
Dented  
Over 30mm

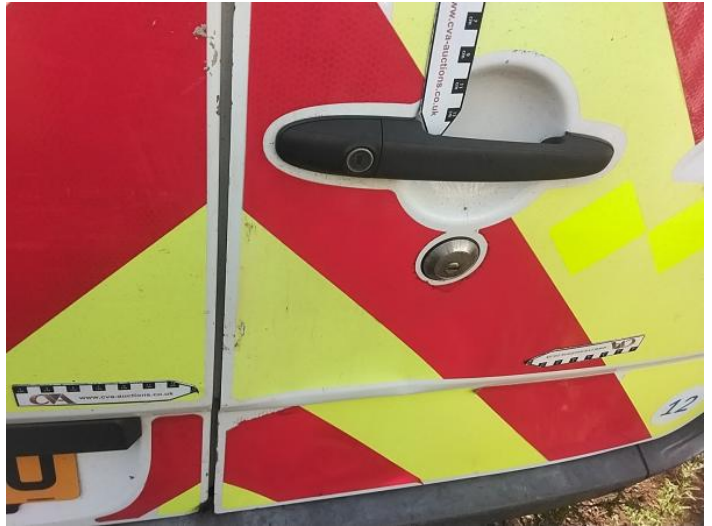
16: Door osr  
Dented  
Over 30mm

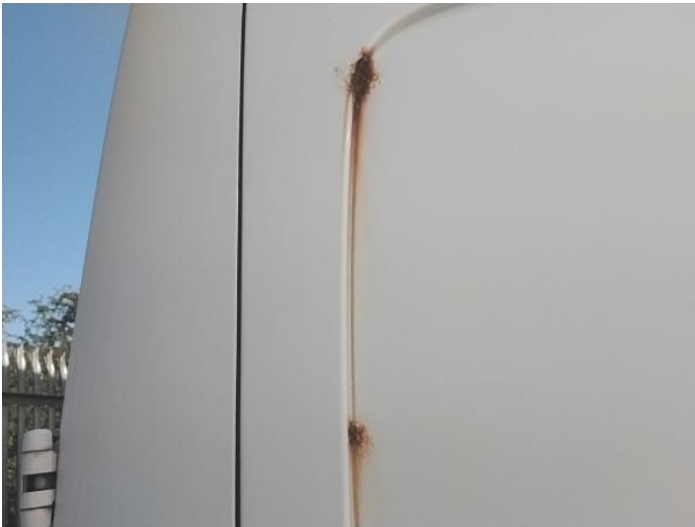
17: Qtr Panel osr  
Rusted  
Over 5mm

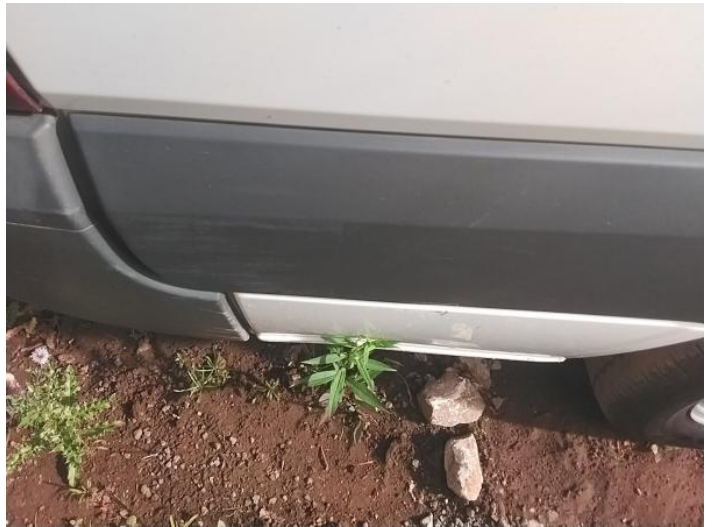
18: Qtr Panel Moulding os  
Scuffed (Unpainted)  
Over 100mm

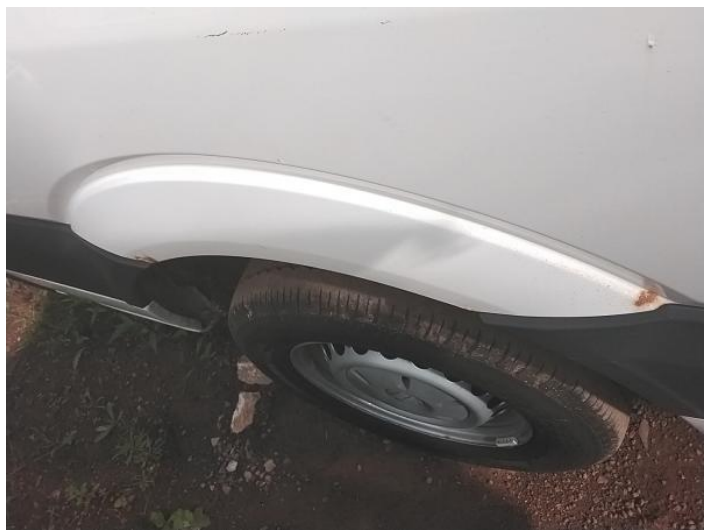
20: Qtr Panel osr  
Dented  
Over 30mm

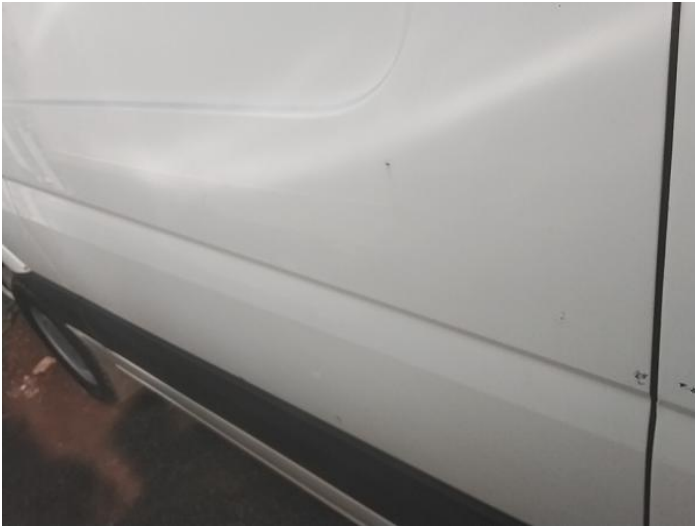
21: Qtr Panel osr  
Chipped  
Multiple Chips

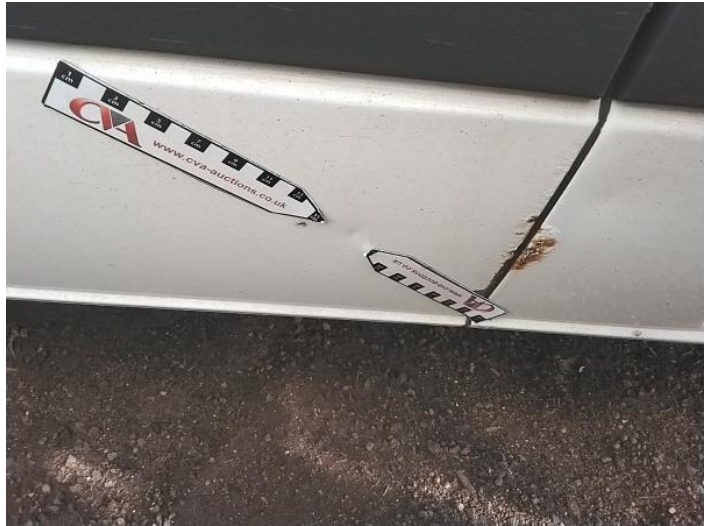
22: Qtr Panel osr  
Dented  
Over 30mm

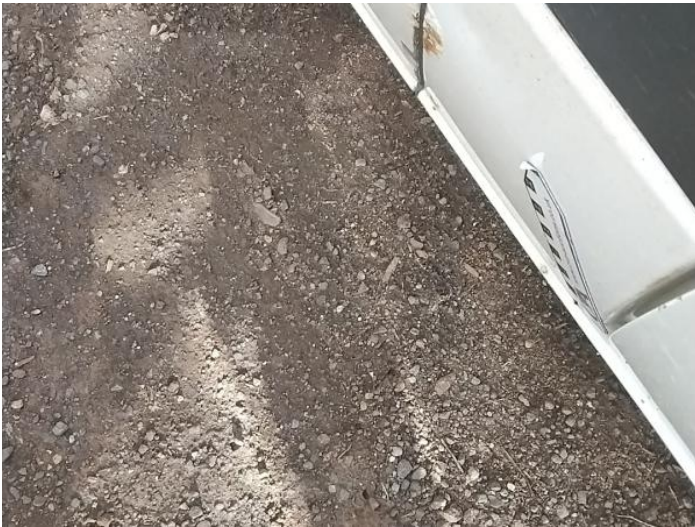
23: B Post os  
Dented  
Over 30mm

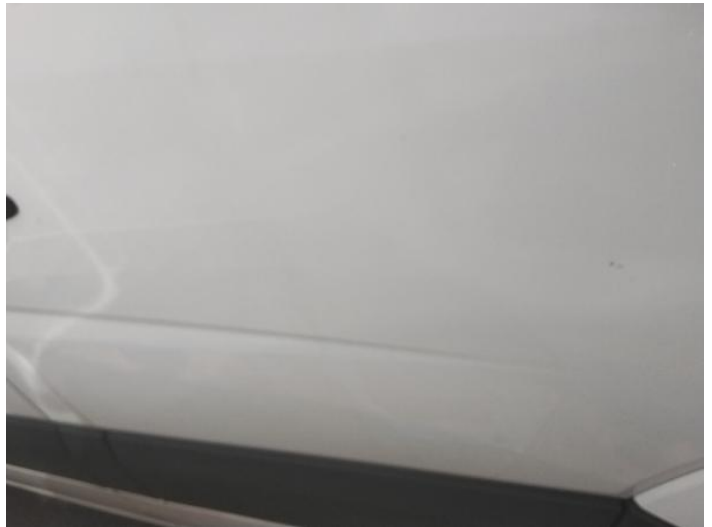
24: Door osf  
Chipped  
Multiple Chips

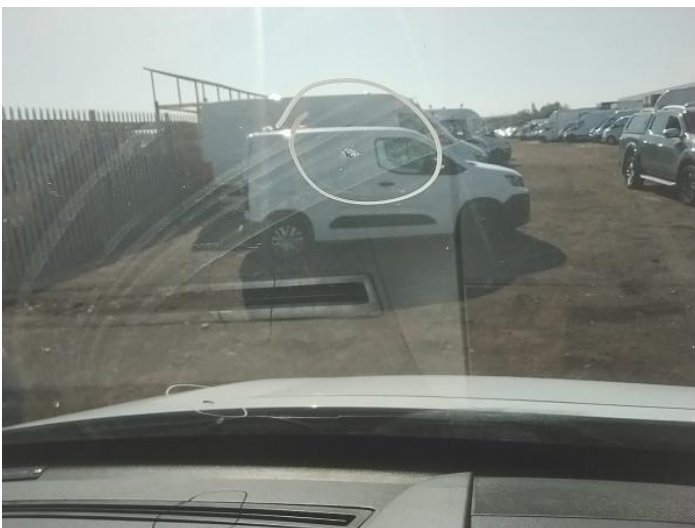
25: Screen Front  
Chipped  
Over 10mm

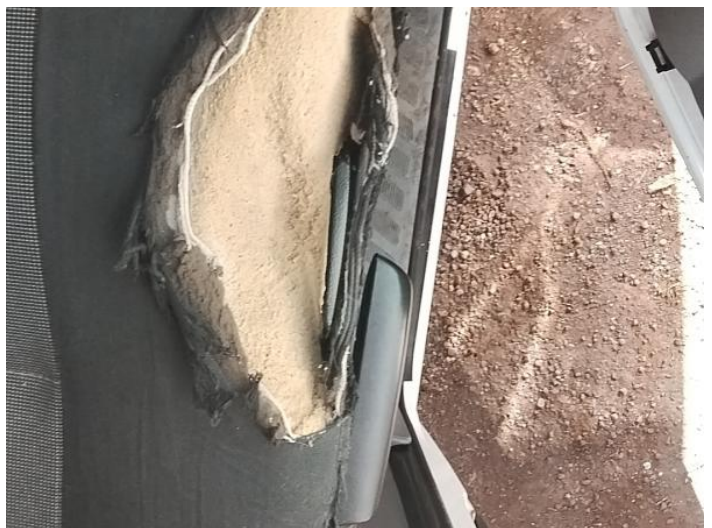
26: Seat Base Cover osf  
Torn  
Over 3mm

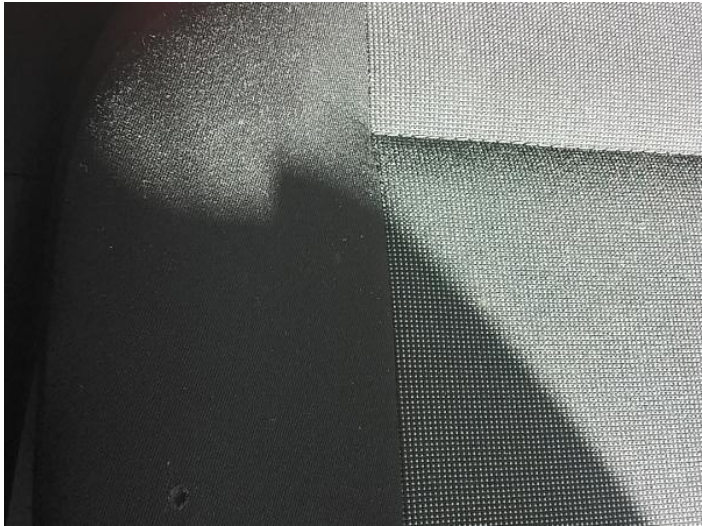
27: Seat Base Cover nsf  
Burn  
Over 3mm
