VEHICLE INSPECTION REPORT

RV70DEU

Iveco Eurocargo 75-160

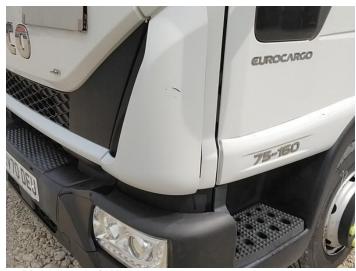
1: Moulding nsf Wing Scratched (Painted) Over 25mm Thru Paint

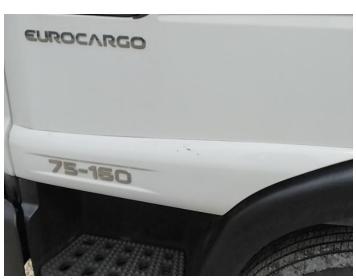
2: Door nsf Scratched Over 25mm Thru Paint

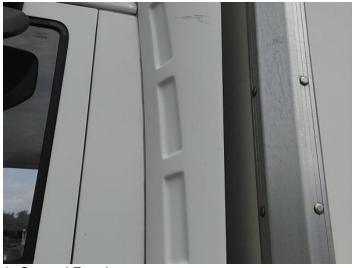
3: General Exterior Soiled Light

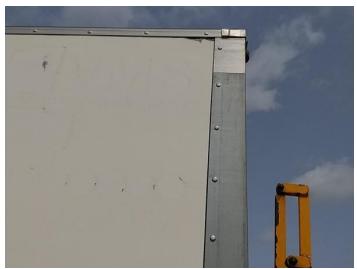
4: General Exterior Soiled Light

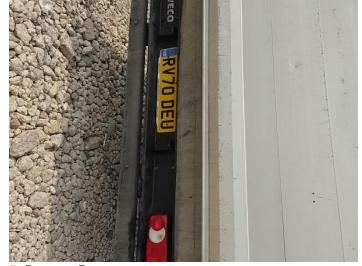
5: Bumper Rear Rusted Over 5mm
